**SECOND  
FIVE-YEAR REVIEW REPORT  
BEULAH LANDFILL  
SUPERFUND SITE  
PENSACOLA,  
ESCAMBIA COUNTY, FLORIDA  
EPA ID: FLD980494660**

**SECOND  
FIVE-YEAR REVIEW REPORT  
FOR  
BEULAH LANDFILL  
FORMER SUPERFUND SITE  
PENSACOLA,  
ESCAMBIA COUNTY, FLORIDA  
EPA ID: FLD980494660**

**BEULAH LANDFILL SITE  
PENSACOLA, FLORIDA  
SECOND FIVE-YEAR REVIEW REPORT**

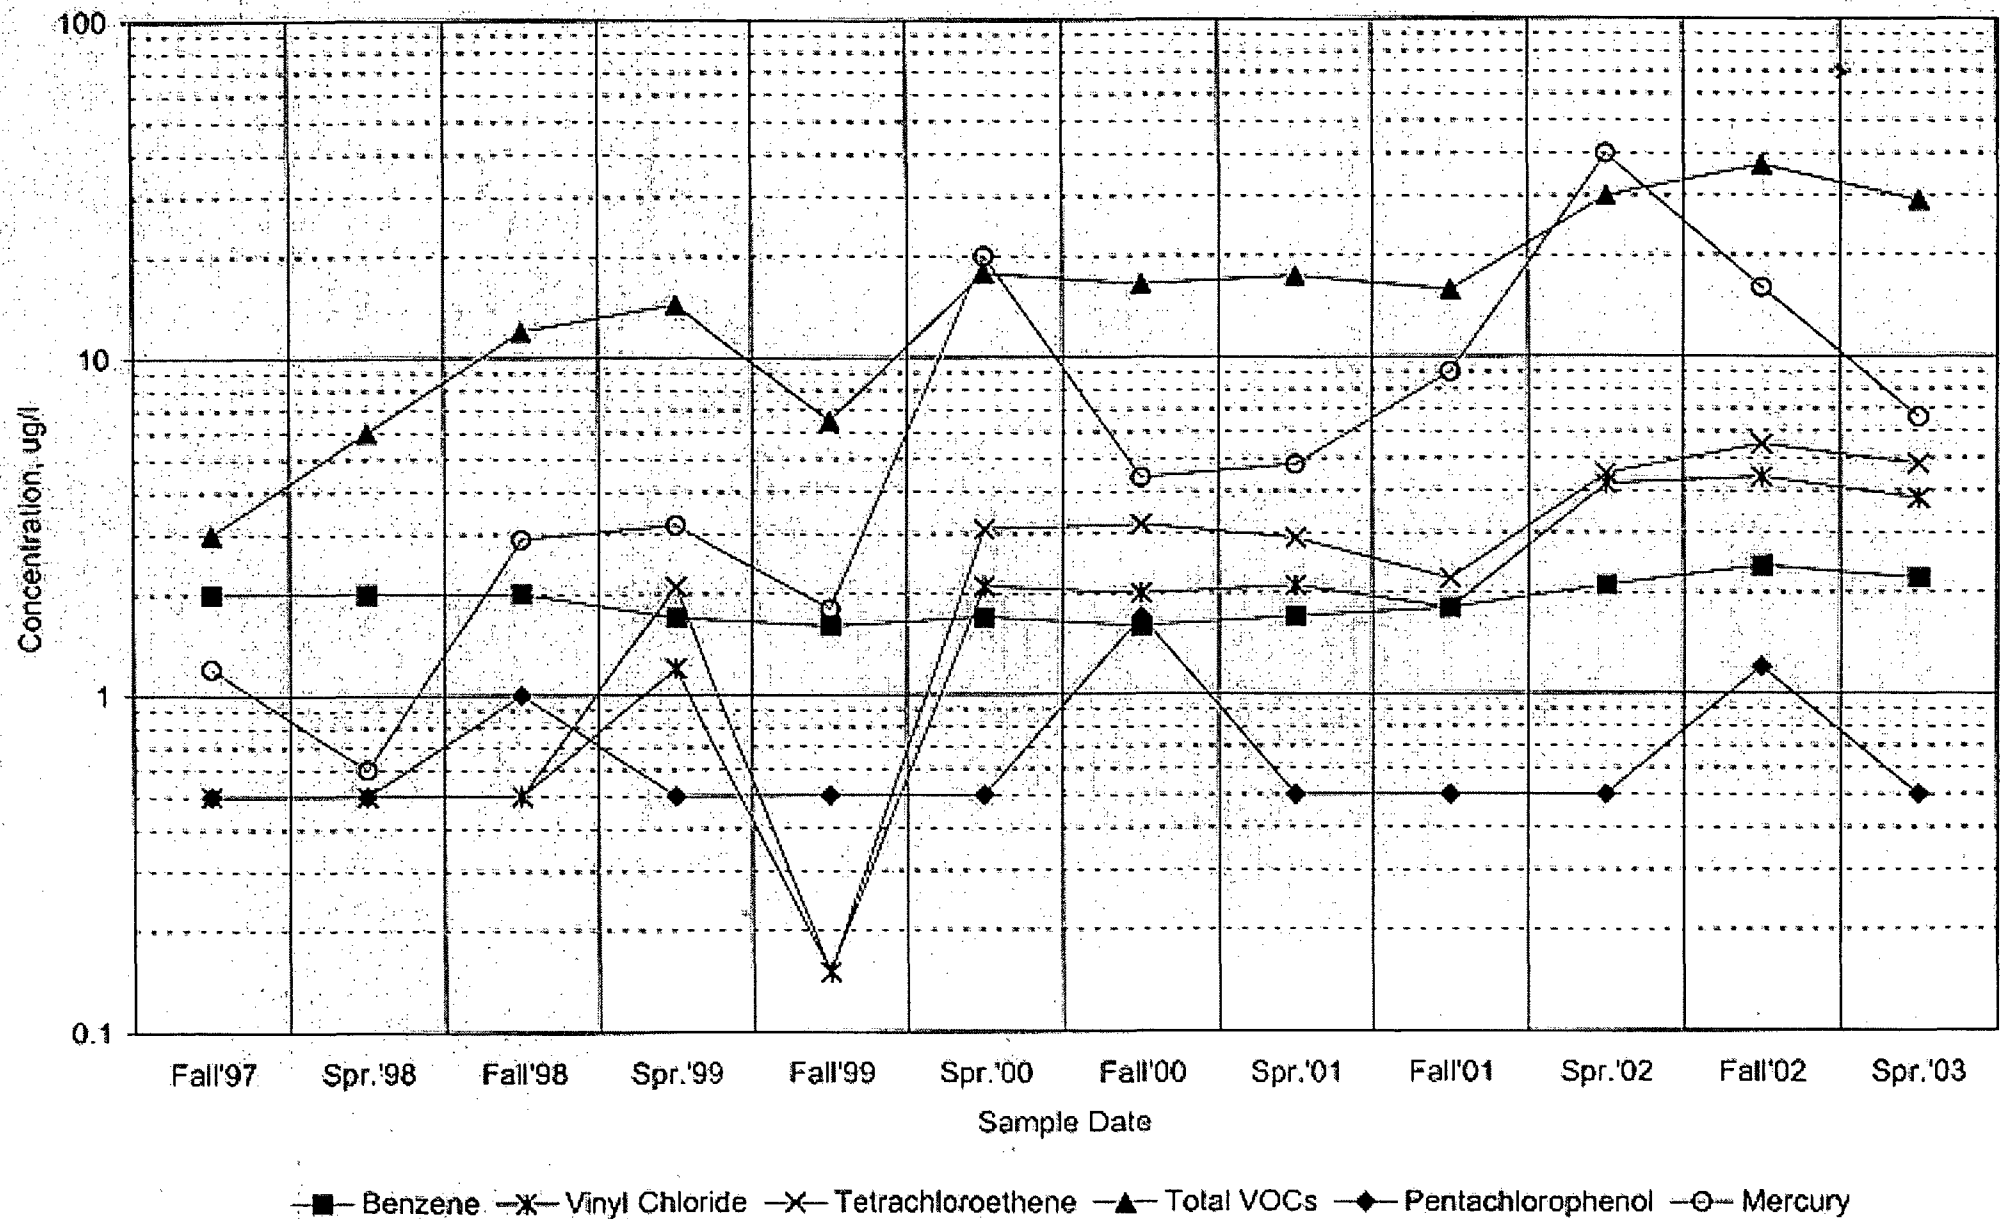
ANALYTICAL HISTORY: BMW-1/1R  
BEULAH LANDFILL, ESCAMBA CO., FLORIDA  
(all values in ug/l)

Sample Location	Contaminants	Date of Exceedance
BMW-1R	Benzene	Fall 1998, Spring 1999, Spring 2000, Fall 2000, Spring 2001, Fall 2001, Spring 2002, Fall 2002, Spring 2003
	Tetrachloroethene	Spring 2000, Fall 2000, Spring 2002, Spring 2003
	Vinyl Chloride	Spring 2000, Fall 2000, Spring 2001, Fall 2001, Spring 2002, Fall 2002, Spring 2003
	Pentachlorophenol	Fall 2000, Fall 2002
MW-6	Pentachlorophenol	Fall 1998, Spring 1999, Spring 2000, Spring 2001, Fall 2001, Spring 2002, Fall 2002, Spring 2003
MW-9	Benzene	Spring 2000, Fall 2001, Spring 2002, Spring 2003
	Pentachlorophenol	Fall 2002
SW-3	Pentachlorophenol	Spring 2000
SW-6	Pentachlorophenol	Spring 2000

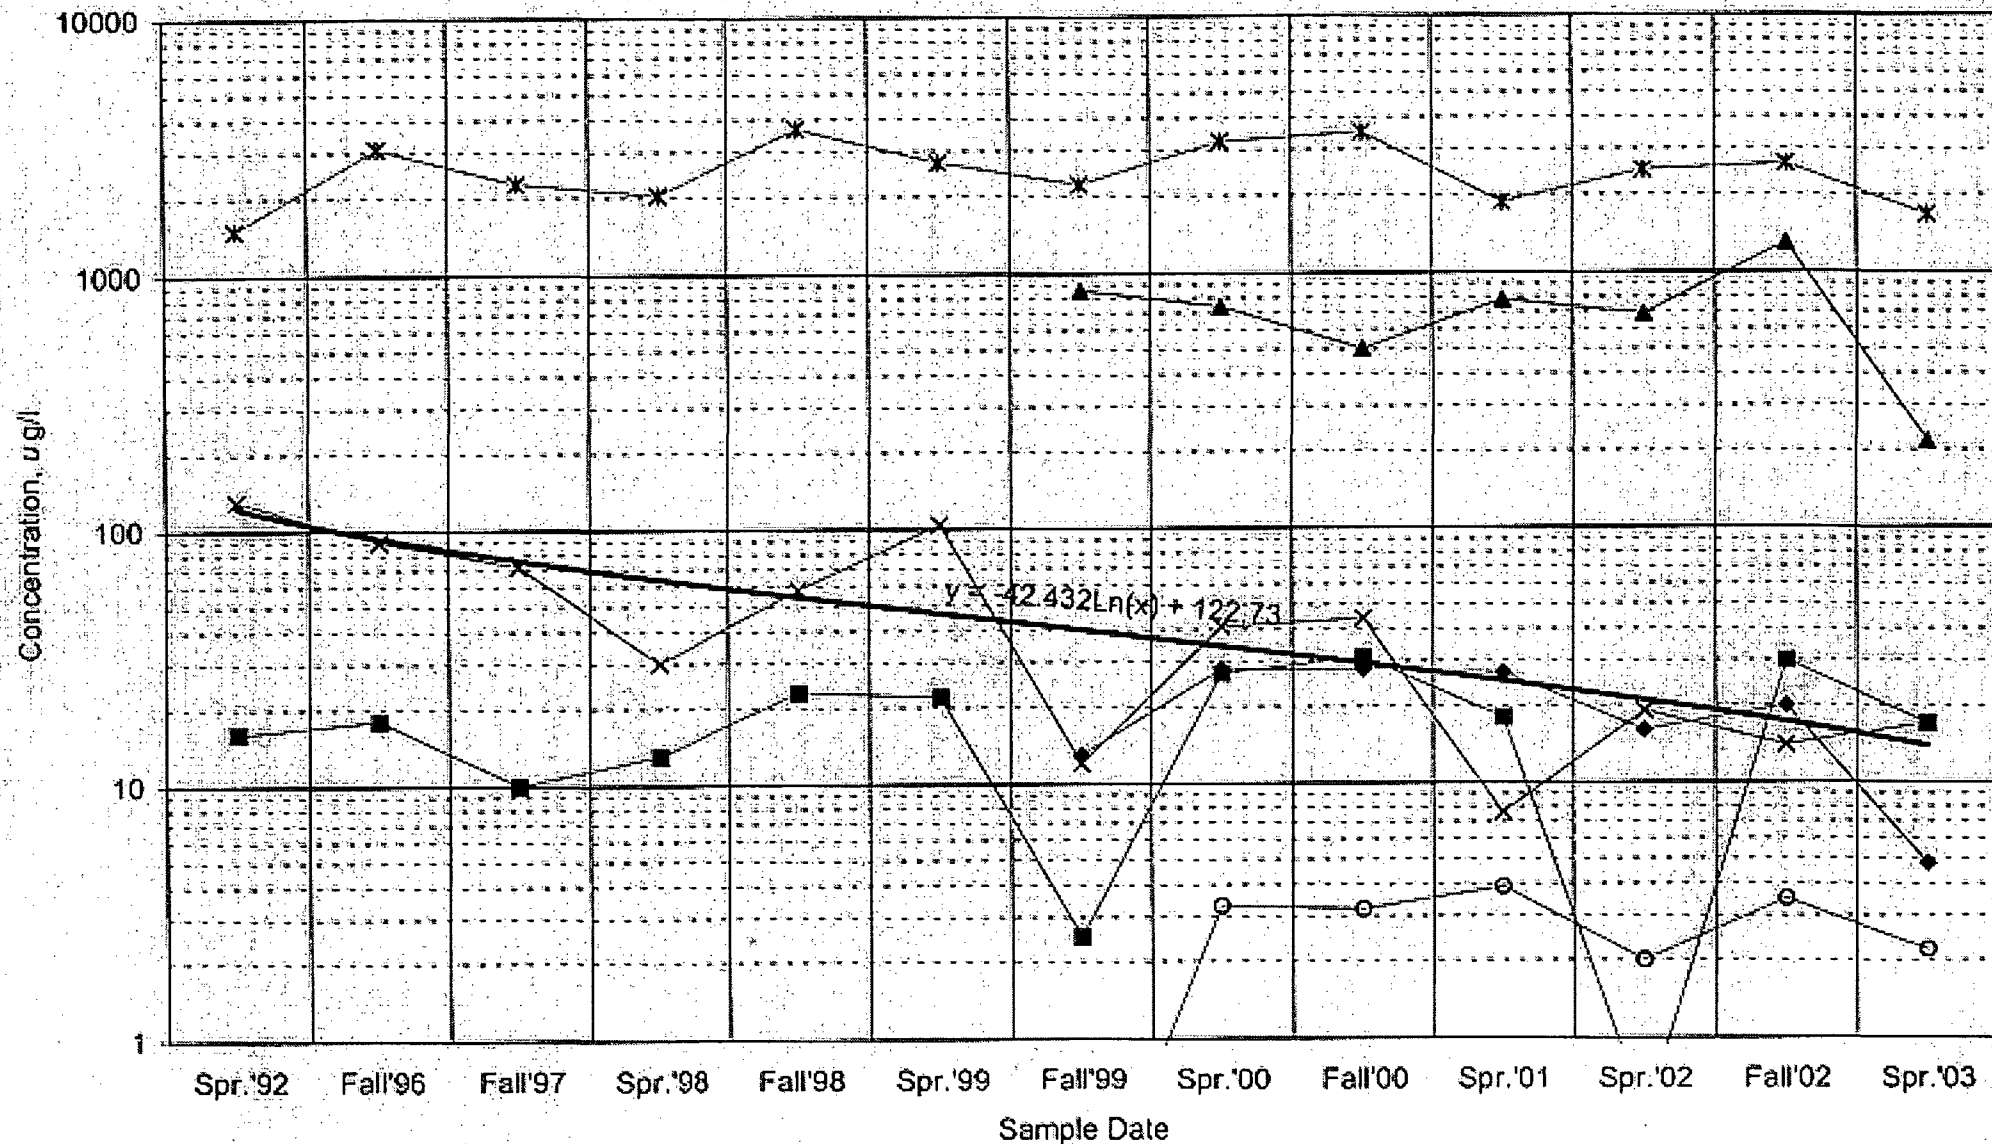
ANALYTICAL HISTORY; MW-6 & MW-9  
BEULAH LANDFILL, ESCAMBIA CO., FLORIDA

■ Total BTEX, MW-6    x Total SVOC, MW-6    x PCP at MW-6    ▲ Total SVOC, MW-9  
 ◆ Total BTEX, MW-9    o Benzene, MW-9    — Log. (PCP at MW-6)

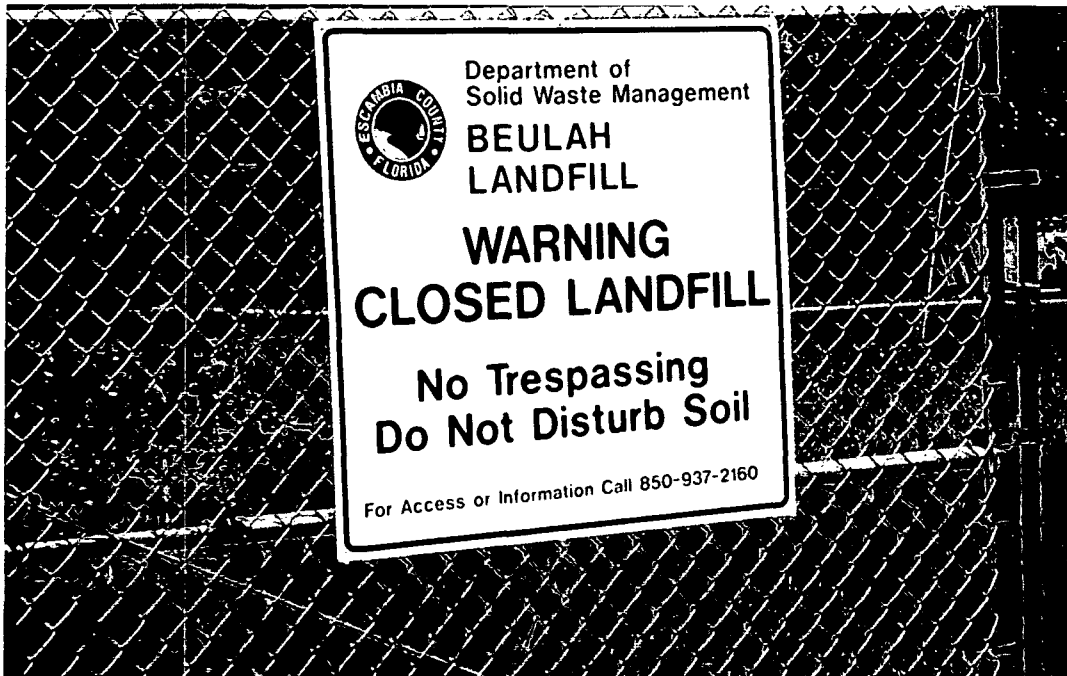
The main entrance into Beulah Landfill was locked and provided with the appropriate signage marked with "no trespassing" and "do not disturb soil". This is the only entrance provided for vehicular traffic and the road was noted to be in good condition. This road continues around the perimeter of the northern half and southern half of the landfill and provides access to the monitor wells and surface water sampling locations.

PHOTOGRAPH 1. Entrance gate to Beulah Landfill

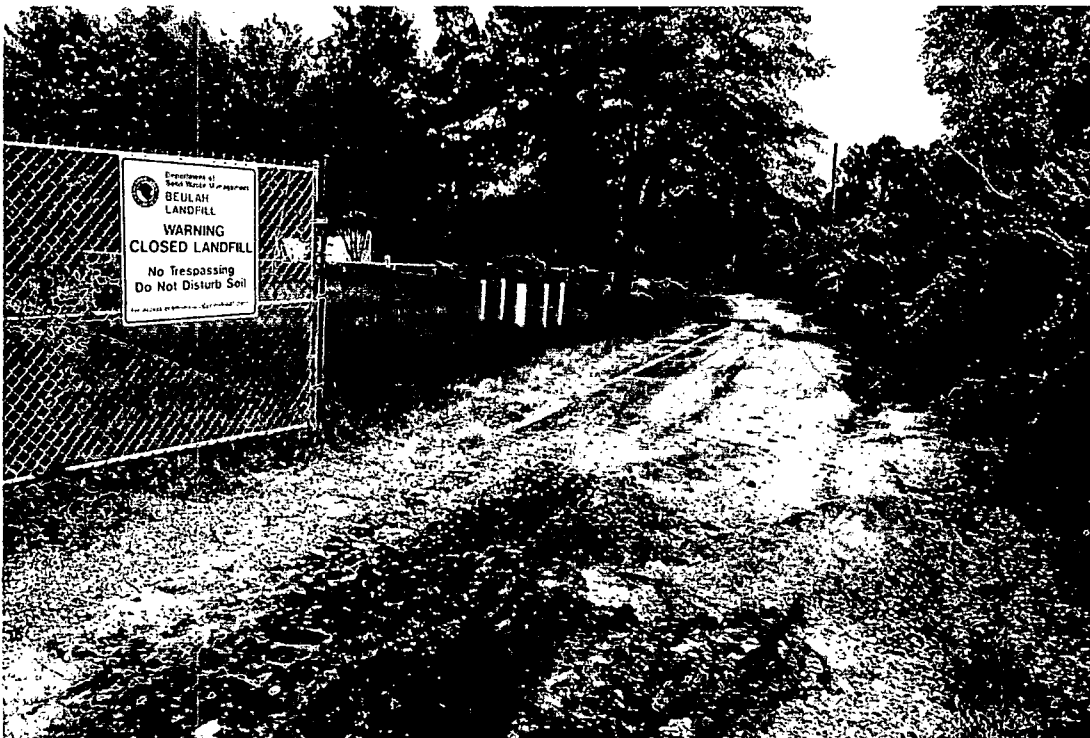
PHOTOGRAPH 2. Entrance road to Beulah Landfill.  
MW-10 shown in center with perimeter fencing and adjacent residences shown on left.

1. **Incomplete Perimeter Fencing** – The perimeter fencing should be completed to protect the cap from damage. The trespasser scenario performed during the risk assessment indicated that there was not an unacceptable risk. The risk assessment was conducted before the cap was installed over the landfill, which further reduced the risk from direct exposure. Although the lack of complete perimeter fencing does not represent a threat to human health of the environment, it is recommended that the perimeter fence be completed to protect the cap from damage by trespassers.

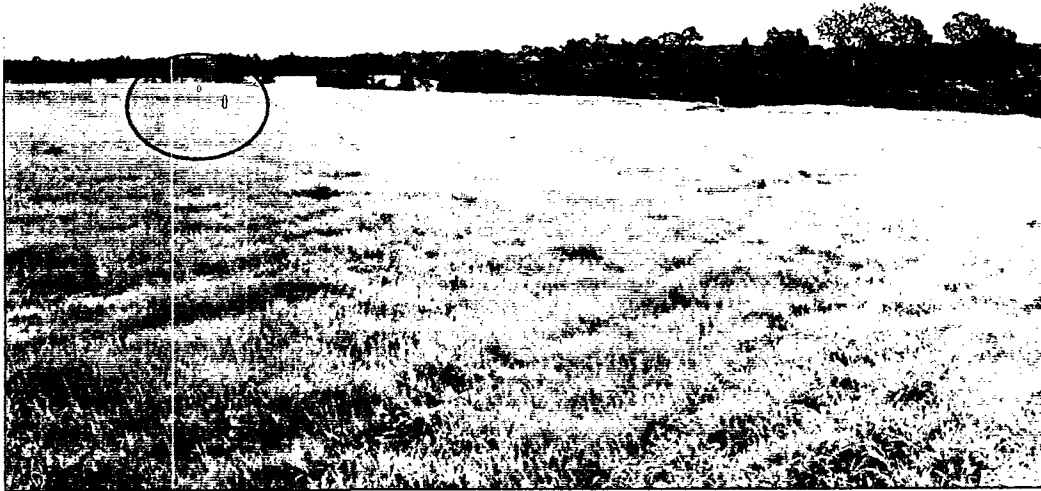
The surface of the landfill has a good vegetative cover of grass (Photographs 3 and 4), and the berms and drainage flumes are in good condition. No major areas of erosion were noted. Mr. Hixson stated that occasional trespassers with motor bikes have caused minor erosion damage but it is repaired as needed.

PHOTOGRAPH 3. View of northern half of Beulah Landfill.  
Gas vents (yellow) shown in circle.

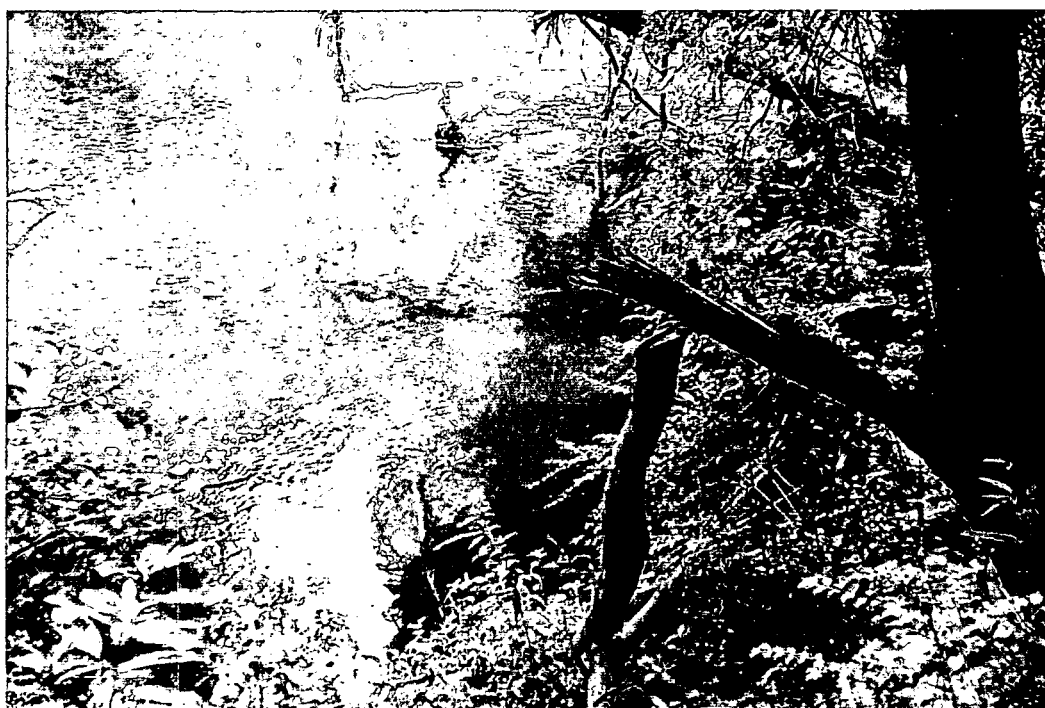
Each surface water sampling location was noted during the inspection as shown on the site diagram (Photographs 6 and 7). No signage was posted to indicate the exact location where surface water samples are collected.

PHOTOGRAPH 6. View of surface water sampling location.

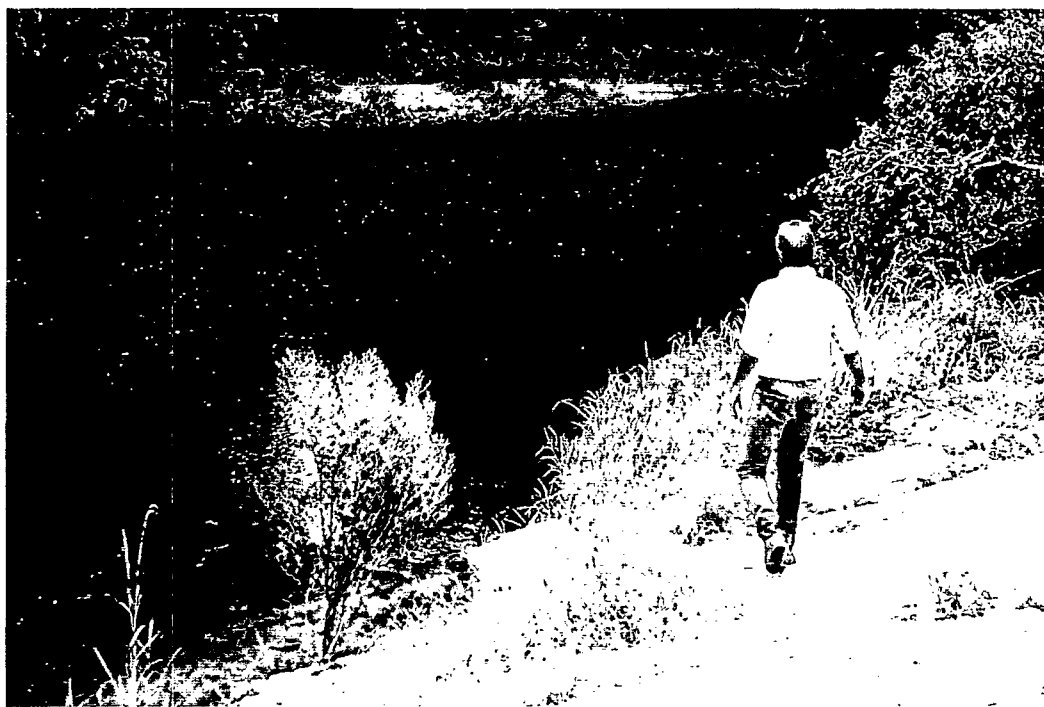
PHOTOGRAPH 7. View of surface water sampling location

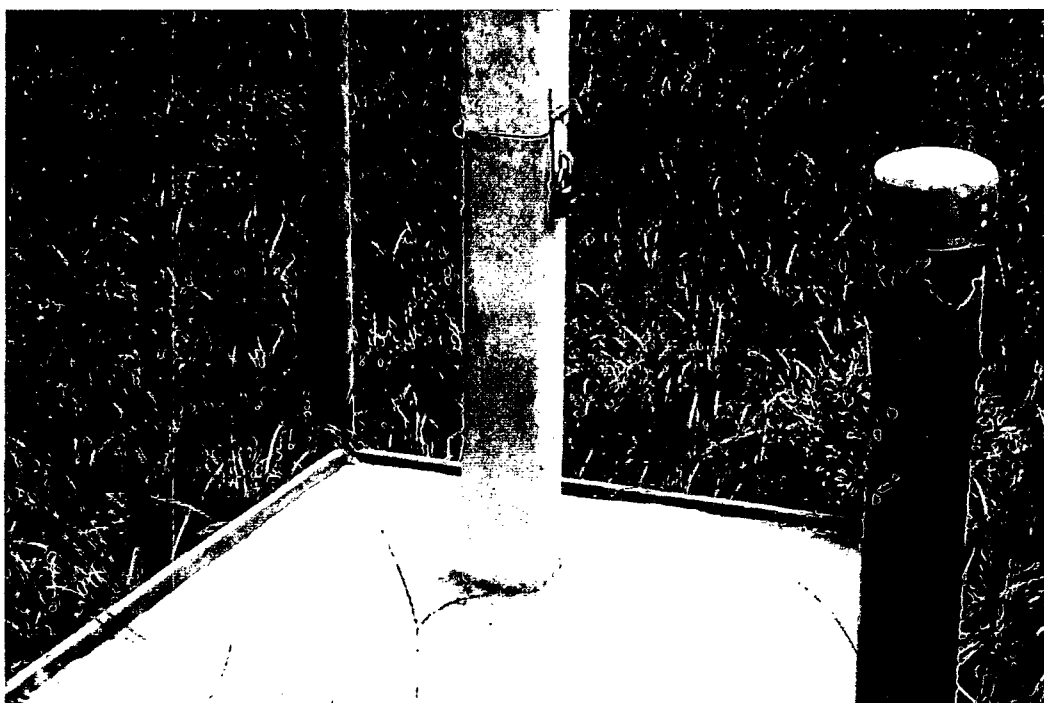
Each of the eleven monitor wells at the site was located at the time of the inspection and noted for condition. Monitor wells at the site were all provided with protective steel surface casings, and most with protective steel posts. Each monitor well was provided with a lock with the exception of MW-6 (Photograph 9).

PHOTOGRAPH 8. Typical groundwater monitor well with steel posts, protective surface casing, pad, and security lock.

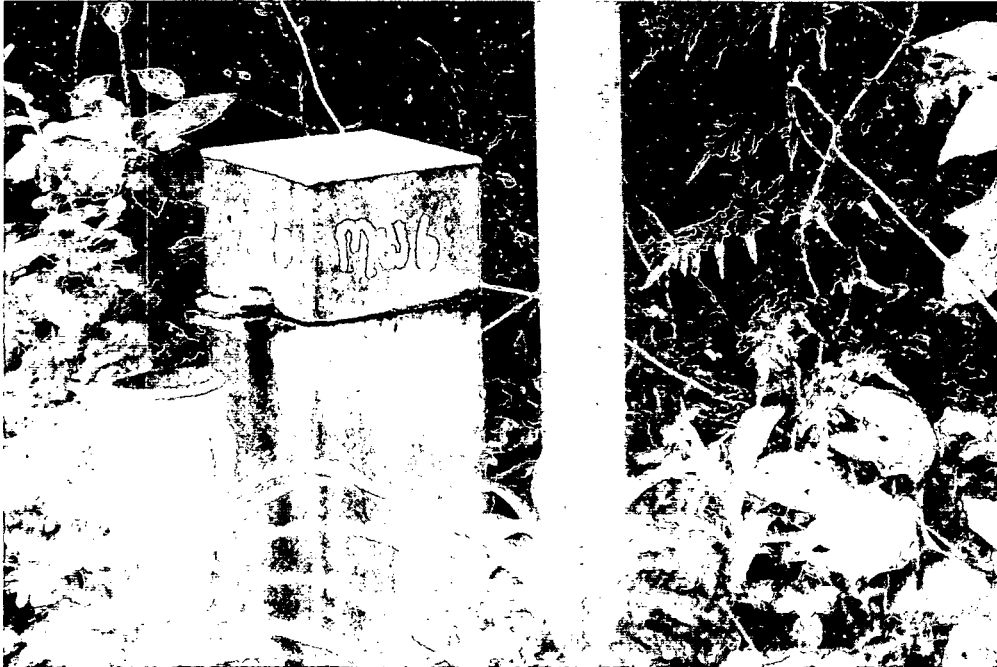
PHOTOGRAPH 9.  
View of MW-6 without lock.

1. The PRP should complete the perimeter fencing and place appropriate signage as soon as possible.
2. The PRP should perform an inventory of the existing monitor wells and replace any locks where necessary.
3. The PRP should submit a plan to FDEP providing the proposed remedial actions to address the contamination indicated in the southern portion of the landfill.
